**WETLAND DELINEATION
FOR THE
CUMRU TOWNSHIP FIRE STATION PROJECT**

Cumru Township, Berks County,
Pennsylvania

Vortex Environmental, Inc.
2819-I Willow Street Pike North
Willow Street, PA 17584
Phone (717) 509-3934 Fax (717) 509-2789

August 9, 2016

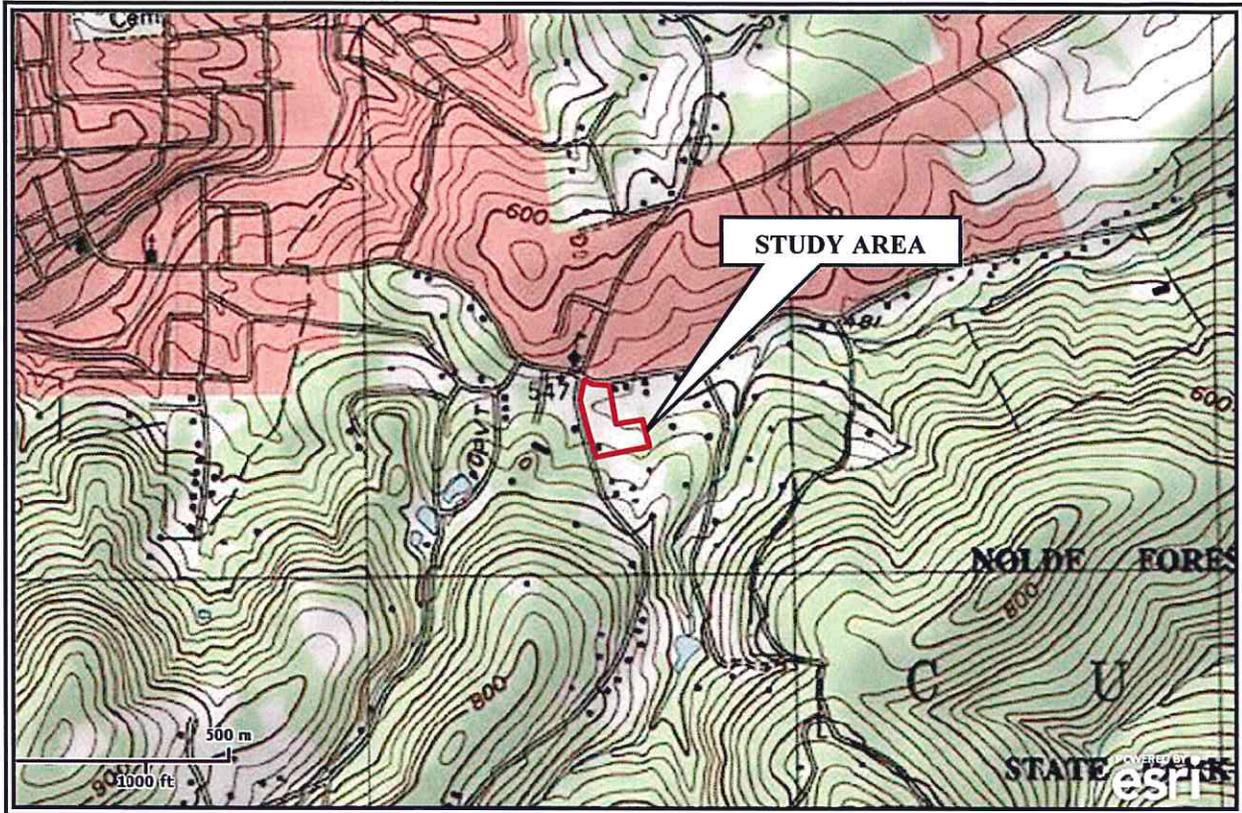
Figure 2: USGS Map for the Cumru Township Fire Station Project
 Reading, PA, 7.5 – minute USGS Topographic Quadrangle
 1956, Photo Revised 1983
 Cumru Township, Berks County, Pennsylvania

The Cumru Township Fire Station Project is comprised of gently rolling to moderately steep topography. Review of the Reading, PA USGS 7.5-minute quadrangle revealed that the existing topography on the study area ranges between 523 and 562 feet in elevation above mean sea level.

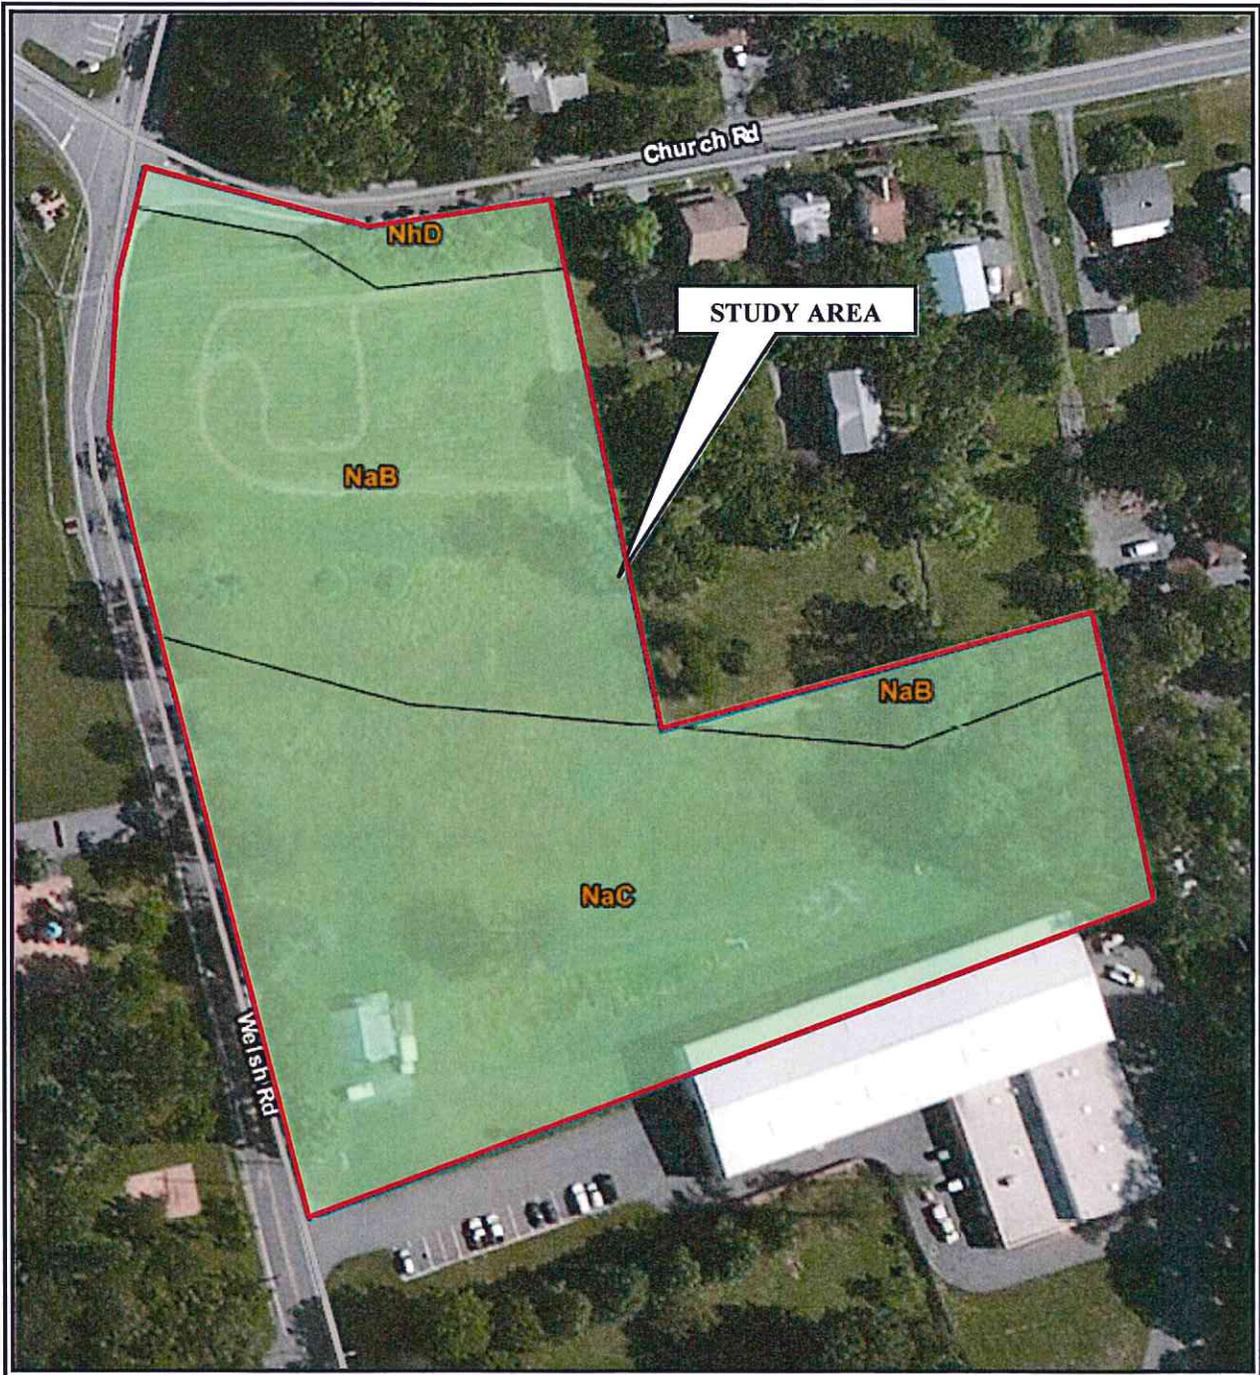
Figure 3: Soil Map for Cumru Township Fire Station Project
 Online Web Soil Survey of Berks County, PA
<http://websoilsurvey.nrcs.usda.gov/app>
 Cumru Township, Berks County, Pennsylvania

Two soil series including three soil types; Neshaminy silt loam, NaB and NaC; and Neshaminy gravelly silt loam, NhD; occur on the Cumru Township Fire Station Project according to the Online Soil Survey for Berks County, PA (Figure 3). These soils are all listed as partially hydric according to the Hydric Soils of the United States and the "Hydric Soils of Berks County". Brief summaries of the soil types are given in Appendix D.

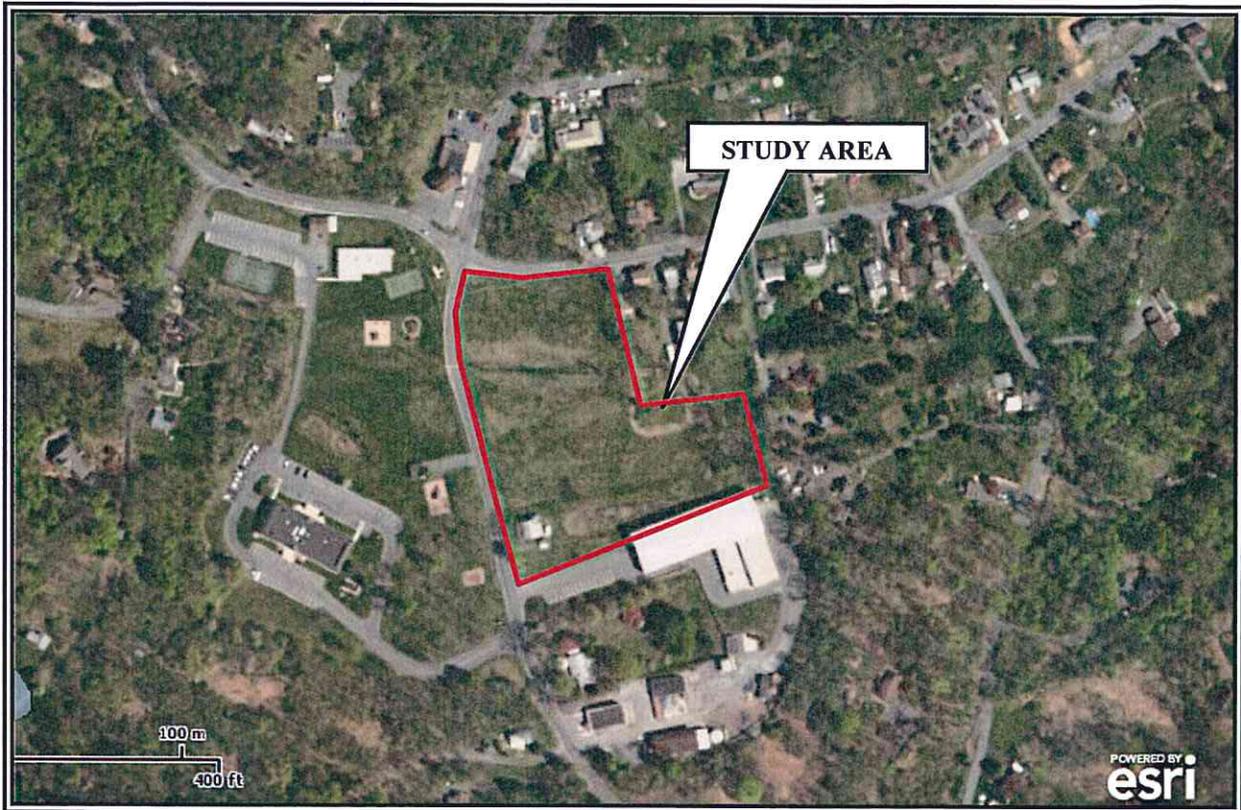
Figure 4: NWI Map for the Cumru Township Fire Station Project
 U.S. Fish and Wildlife Service Wetlands Online Wetland Mapper
<http://wetlandsfws.er.usgs.gov/NWI/index.html>
 Cumru Township, Berks County, Pennsylvania

The National Wetland Inventory (NWI) Overlay Map (U.S. Fish & Wildlife Service Wetlands Online Wetland Mapper) does not indicate the presence of any wetlands, watercourses, or open waters within the study area (Figure 4). The NWI was produced by the United States Fish and Wildlife Service Online Mapper to inventory and classify wetlands using the categories of Cowardin et. al.(1979). NWI maps were not intended to locate regulated wetlands pursuant to the Clean Water Act.

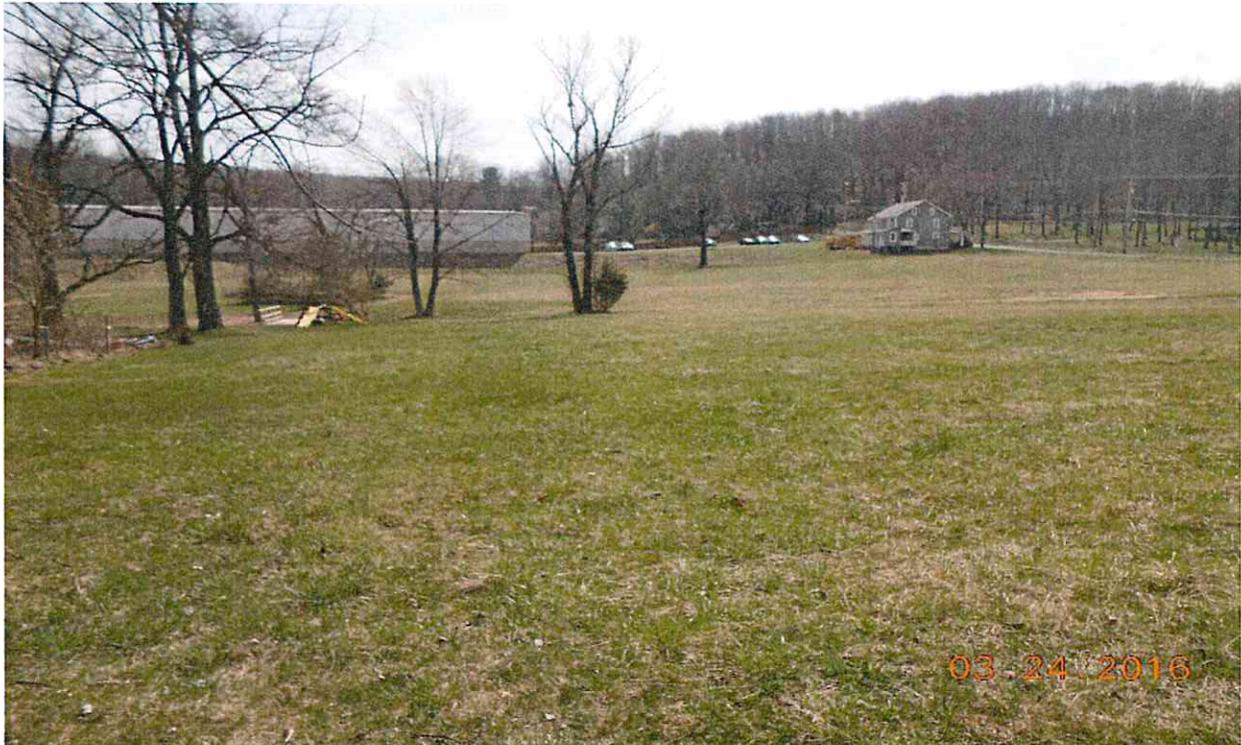
Photo B. Southern view of the old field in the northeastern portion of the study area.

The old field vegetation was observed throughout the northern and central portions of the study area and is occasionally mowed (Sampling Point 2; Photographs B, D, E, N, O, P, W and X). The old field vegetation included Orchard grass, timothy, Canada golden-rod, Canada thistle, common chickweed, common dandelion, curly dock, English plantain, field garlic, giant foxtail grass, Indian grass, Kentucky bluegrass, path rush, purple deadnettle, Queen Annes lance, red clover and multiflora rose. The lack of hydrophytic vegetation and hydrologic characteristics observed within the old field are typical of non-wetland habitats.

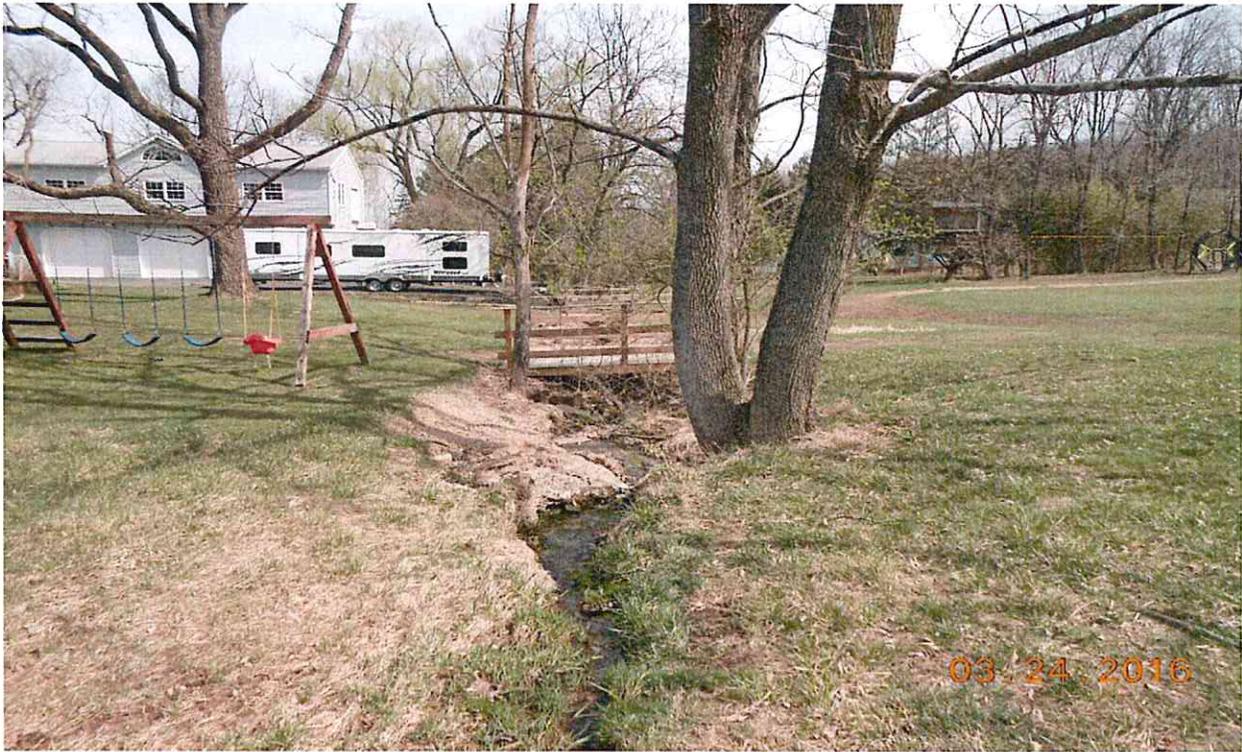
Photo C. Eastern view of Watercourse 1, where it drains off-site along the eastern boundary of the study area.

Watercourse 1 (UNT to Angelica Creek) originates at an existing stormwater culvert outfall along Welsh Road, then drains to the east through Wetland 1, before flowing off-site along the eastern boundary of the study area. At the time of our investigation, Watercourse 1 was approximately 3 to 4 feet wide with banks approximately six inches feet high (Photographs C, F, K and L). Side slopes of these banks ranged from 1:1 to 3:1. The substrate of the watercourse was a mud bed throughout its' length. The watercourse contained approximately ½ inch of base flow at the time of the investigation.

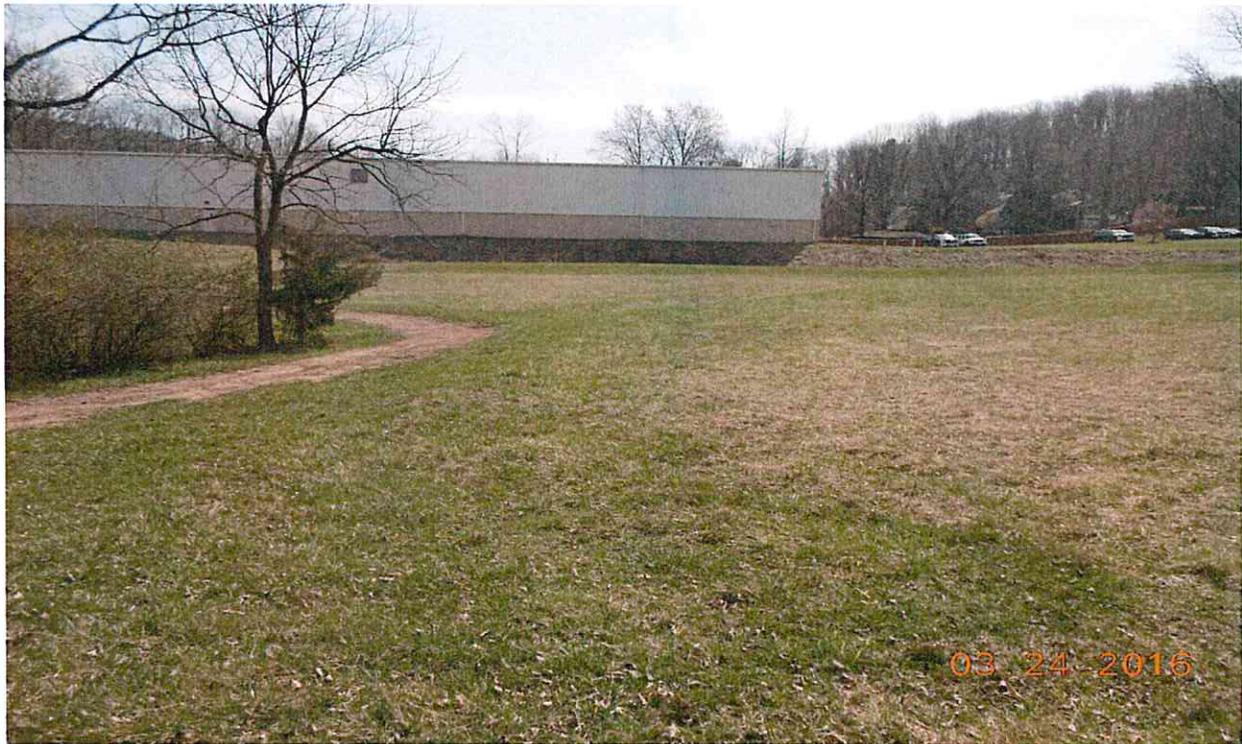
Photo D. Southern view of the old field in the central portion of the study area.

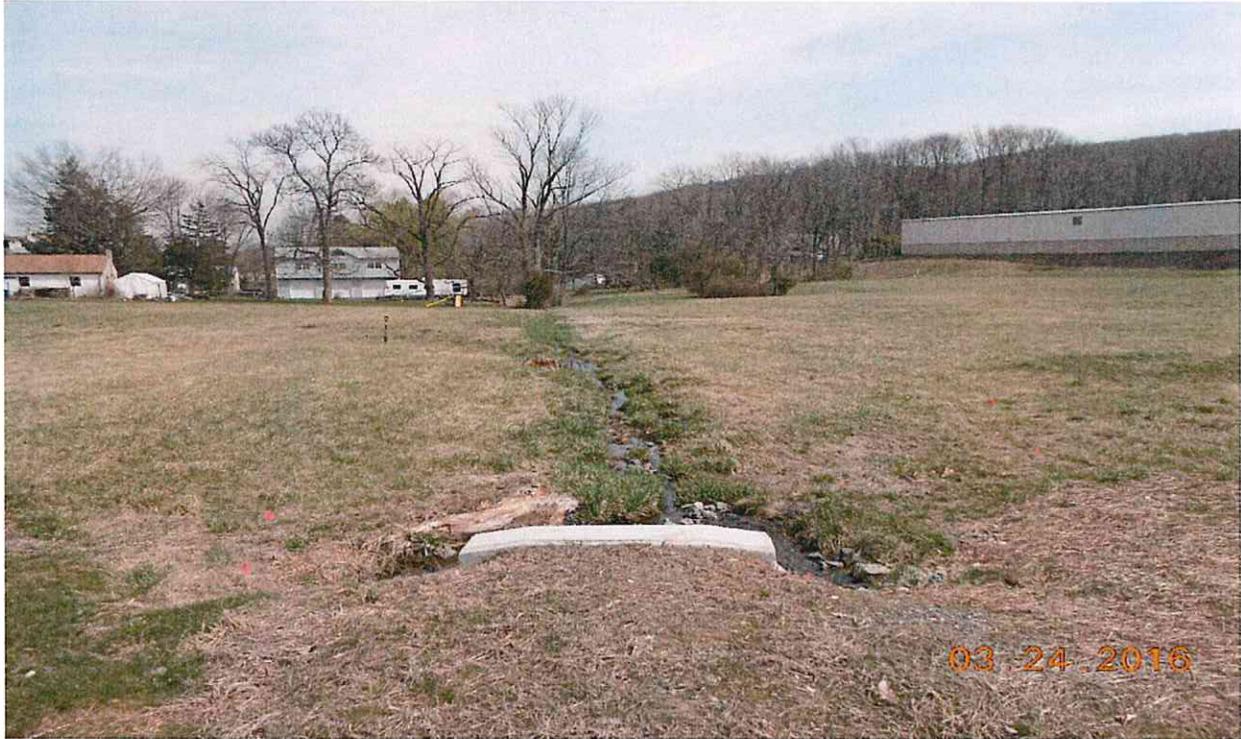
Photo F. Eastern view of Watercourse 1 and the associated wetland area (Wetland 1) from Welsh Road.

The emergent wetland area was associated with low ground slopes, seasonal high groundwater tables, poorly drained soils and the overbank flows from the adjacent intermittent stream channel (Sampling Point 1; Photographs F, I, J, K, L and M). Wetland 1 was located in the central portion of the study area adjacent to Watercourse 1 (UNT to the Angelica Creek). The vegetation within the wetland area consisted of reed canary grass, path rush, common rush and yellow nutsedge. Primary indicators of wetland hydrology observed within the sampling point included saturation in the upper 12 inches, matted vegetation and oxidized root channels in the upper 12 inches of the soil profile. Secondary indicators of wetland hydrology included wetland drainage patterns and geomorphic position. The dominant hydrophytic vegetation and

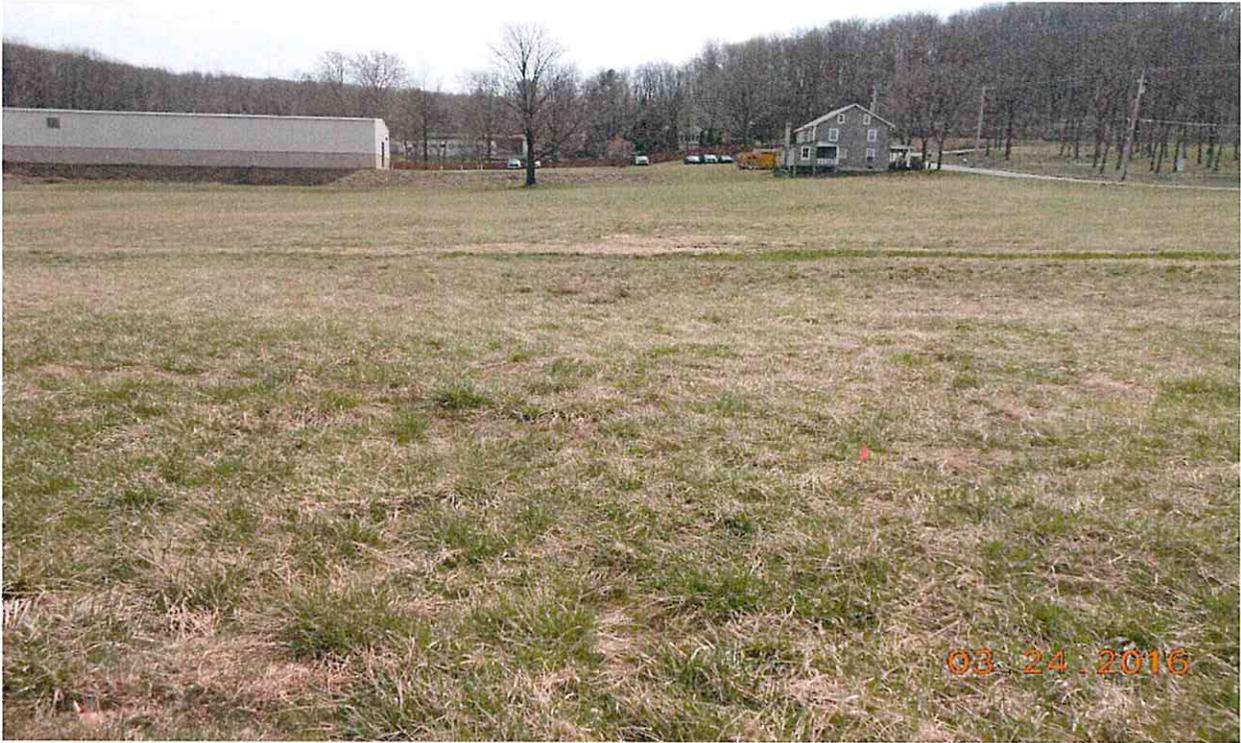
Photo I. Southern view of Wetland 1 in the central portion of the study area.

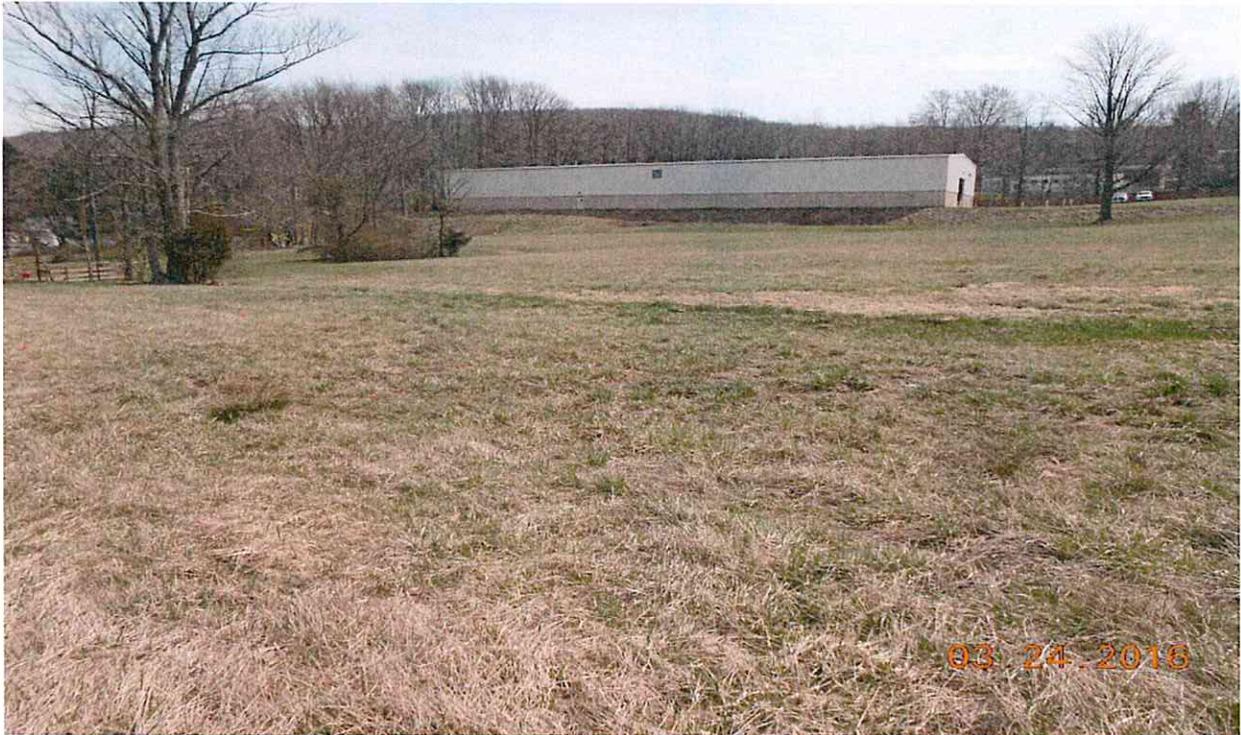
Photo J. Southeastern view of Wetland 1 in the central portion of the study area.

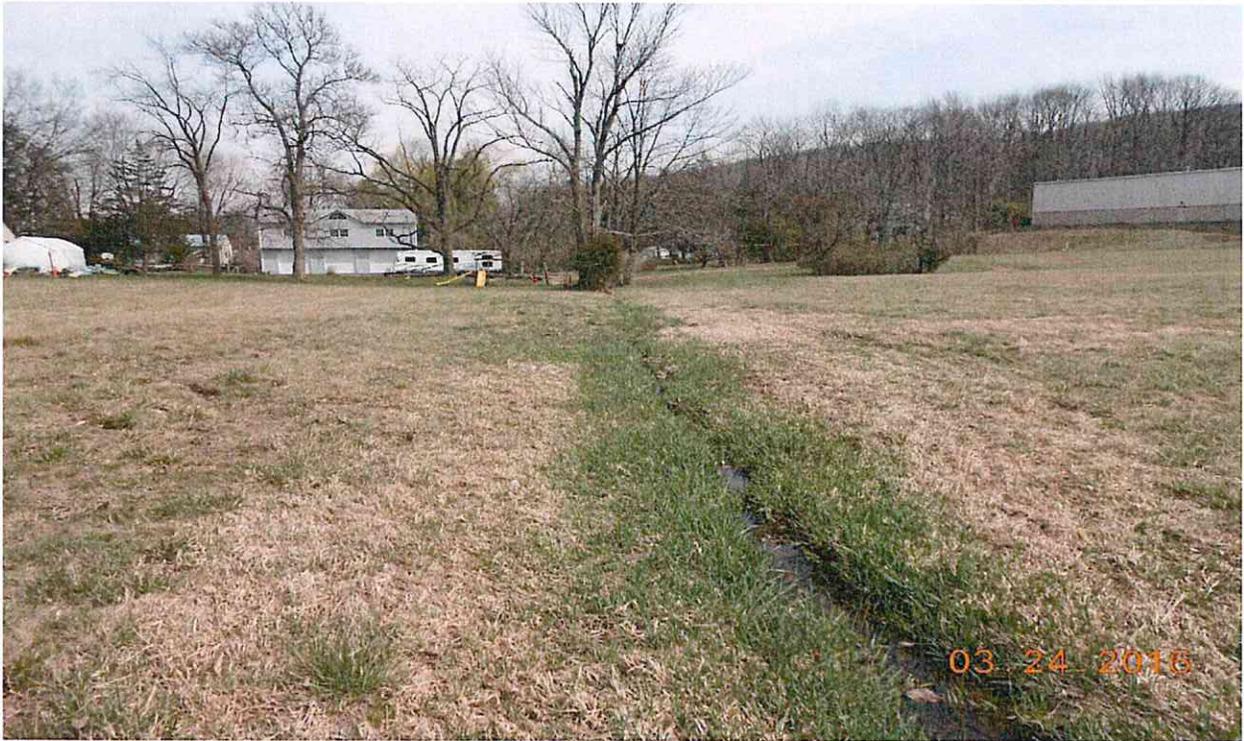
Photo K. Eastern view of Watercourse 1 and Wetland 1 in the central portion of the study area.

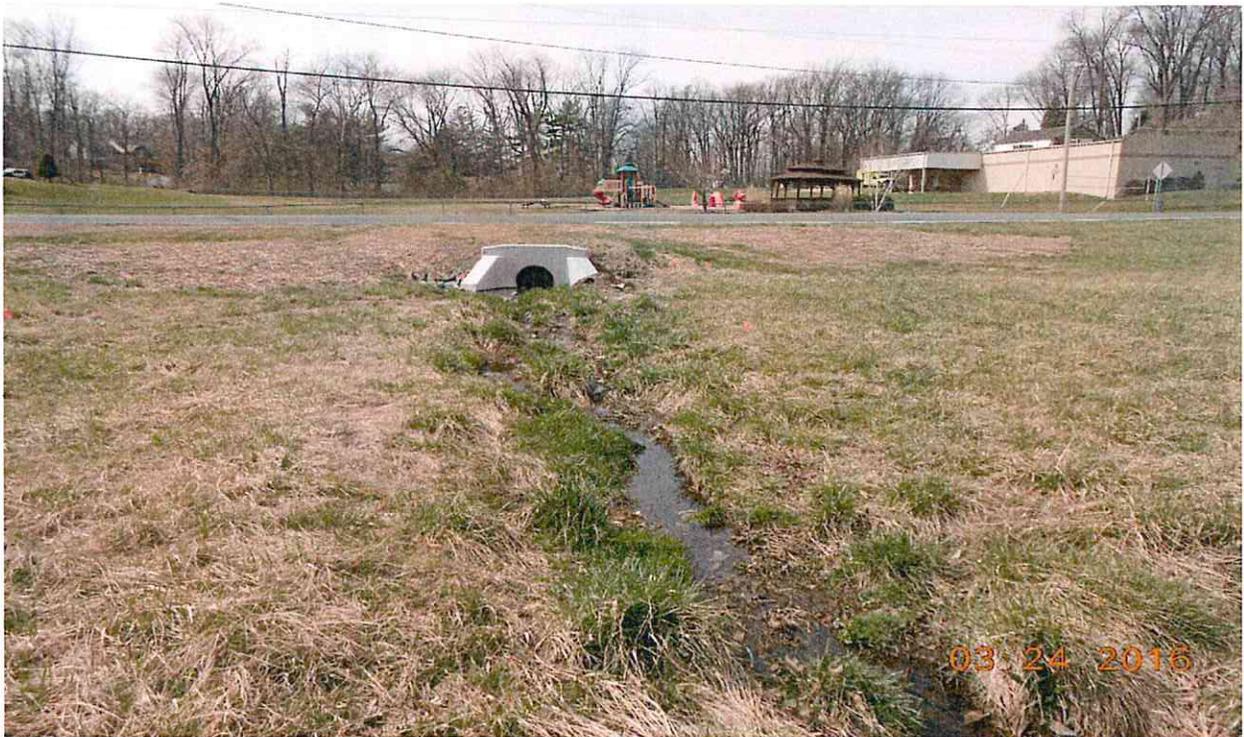
Photo L. Western view of Watercourse 1 and Wetland 1 in the central portion of the study area.

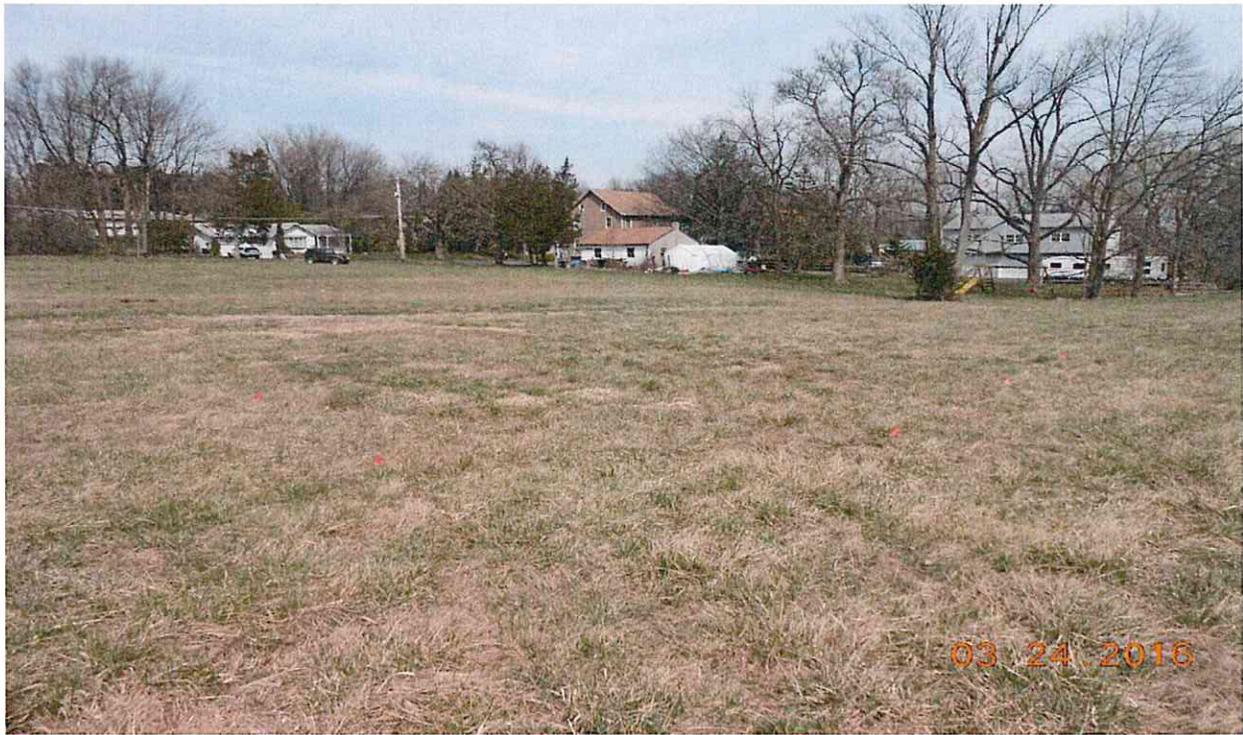
Photo M. Northeastern view of Wetland 1 in the central portion of the study area.

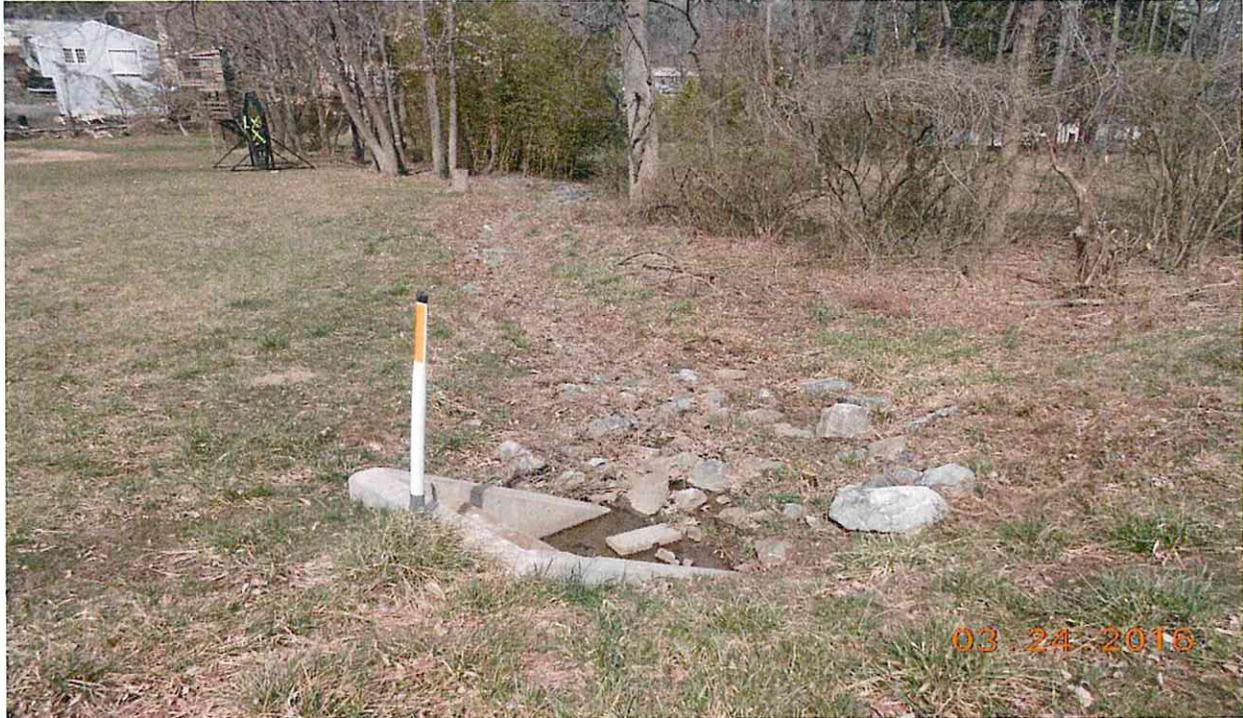
Photo Q. Northern view of the existing rip-rap storm water outfall swale along the eastern boundary of the study area.

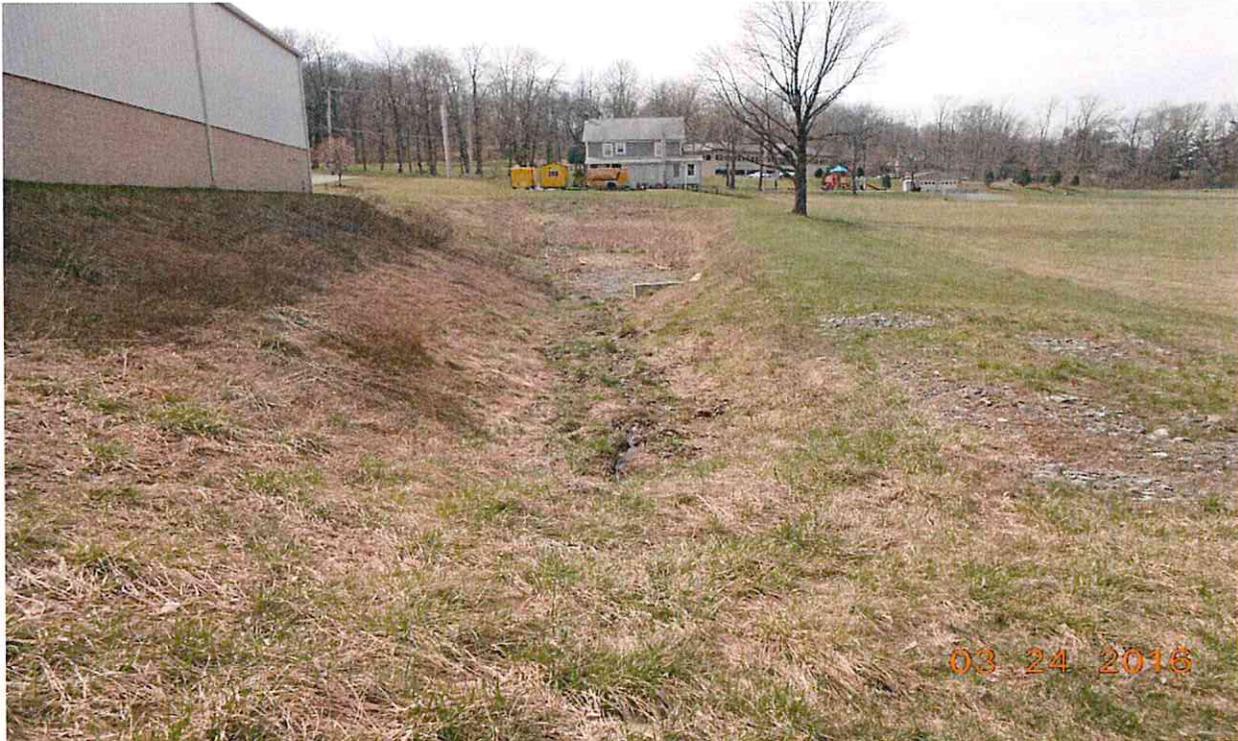
Photo R. Western view of the existing storm water management basin in the southern portion of the study area, adjacent to the existing maintenance building.

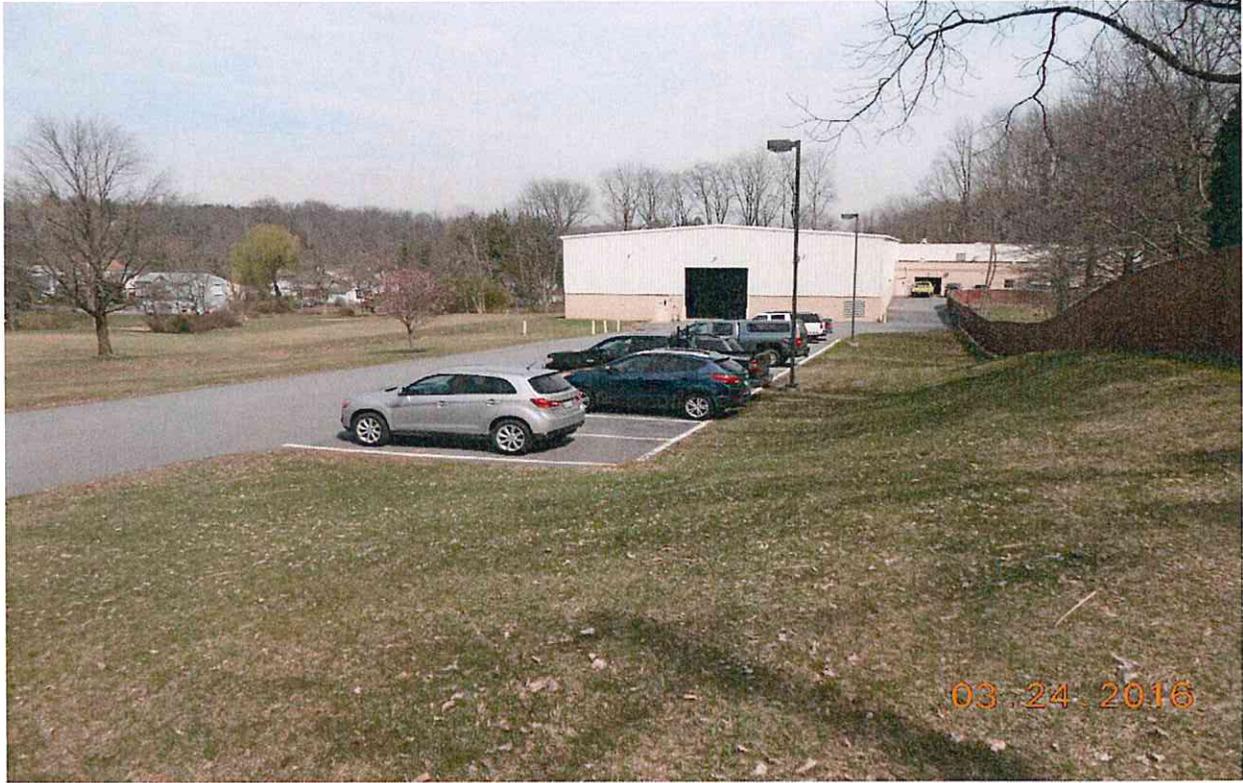
Photo S. Eastern view of the existing maintenance building and associated macadam parking area in the southern portion of the study area.

The mowed lawn was observed in the southern portion of the study area, adjacent to the existing buildings, driveways, and parking areas (Sampling Point 3; Photographs S and T). The mowed lawn vegetation included Kentucky bluegrass, common dandelion, field garlic, ground ivy, Indian strawberry, and white clover. The lack of hydrophytic vegetation and hydrologic characteristics observed within the mowed lawn are typical of non-wetland habitats.

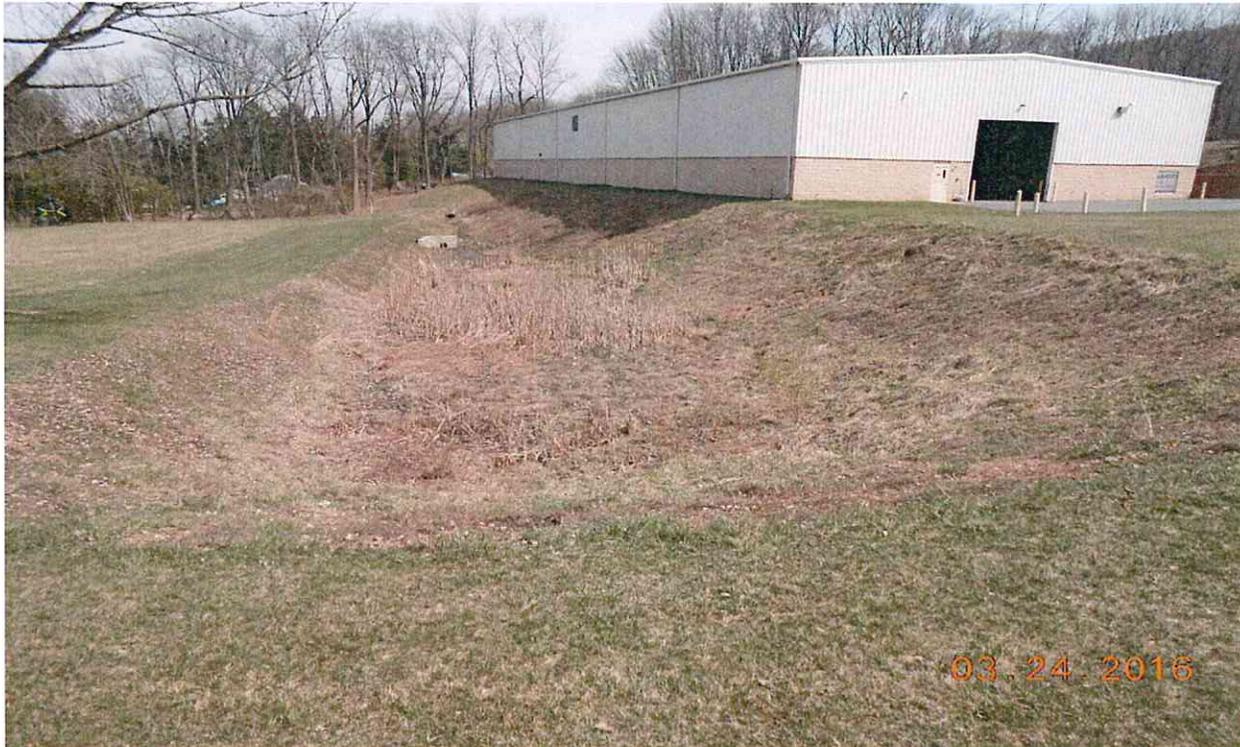
Photo U. Eastern view of the existing storm water management basin in the southern portion of the study area, adjacent to the existing maintenance building.
